April 14, 2006  
Arc Flash Incident  
Building 1006A  
Brookhaven National Laboratory

Jim Tarpinian  
Director  
Environment, Safety, Health and Quality

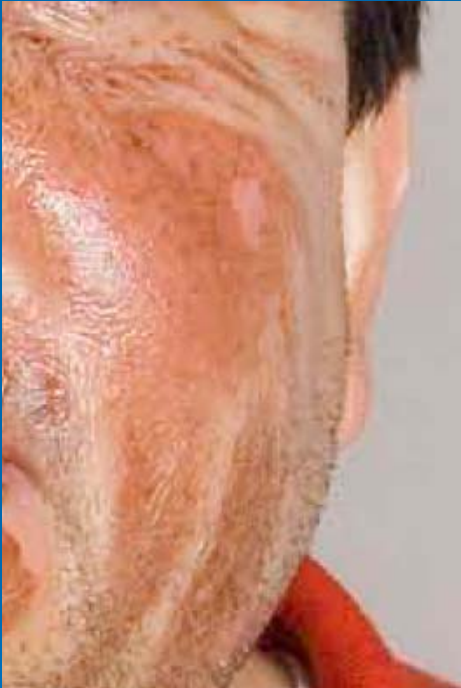
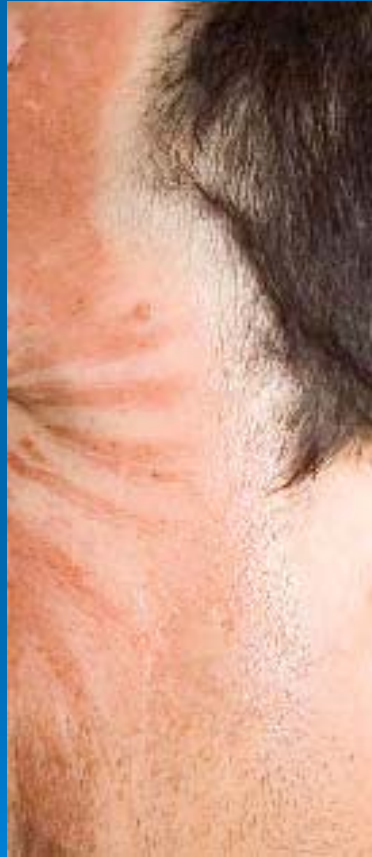
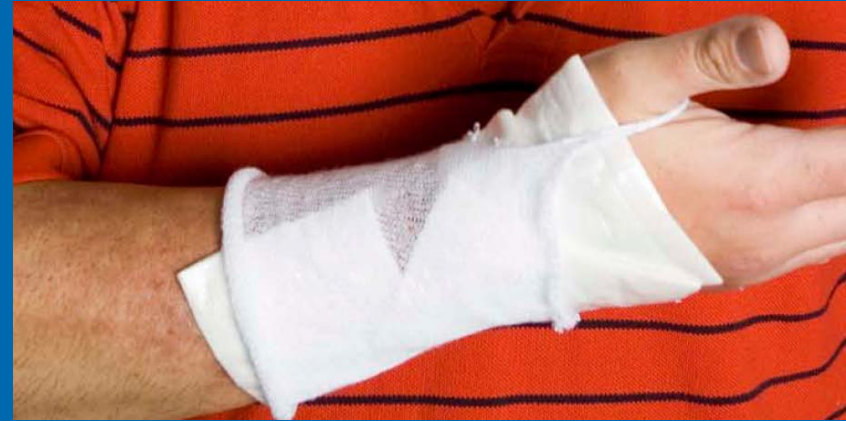
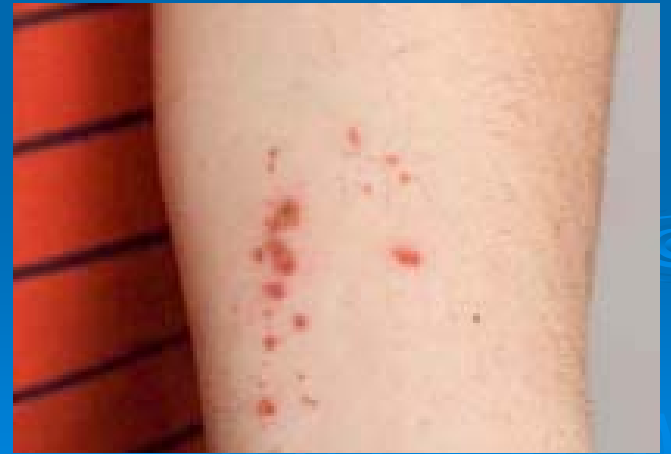
- April 14, 2006 at ~1020
- Building 1006A Mechanical Loft
- Engineer operates 480 V 400 amp disconnect switch
- Arc flash injuries:
  - 1<sup>st</sup> degree burns to head, face, chest, and hands
  - 1<sup>st</sup> and 2<sup>nd</sup> degree burns to forearms
- Switch panel destroyed

# Injury Prevention Recommendations

- Hazard Cat 2 or greater for 480 V CB & switch operation
- Assure that PPE is worn properly

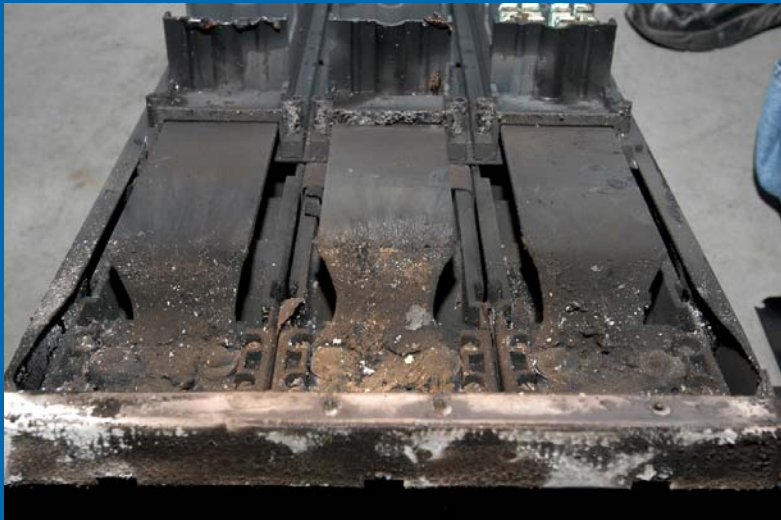
Damaged switch

- High transient voltage
  - Arcing ground fault on ungrounded delta system (possible but unlikely)
- Foreign/loose object
  - Preliminary investigation of a similar switch indicates that the switch may have failed mechanically.
  - Area that show signs of cracking is plastic and is stressed when closing the switch.
  - If this part breaks free, it could allow a metal spring clip to enter the rear bus compartment where the arc flash occurred.

# Accident Prevention Recommendations

- Activate/install ground fault detection systems
- Install systems to minimize voltage transients
- Implement a project plan for energy calculations
- Review other practices:
  - Racking circuit breakers with bus energized
  - Inserting/removing motor control center starter-buckets while energized

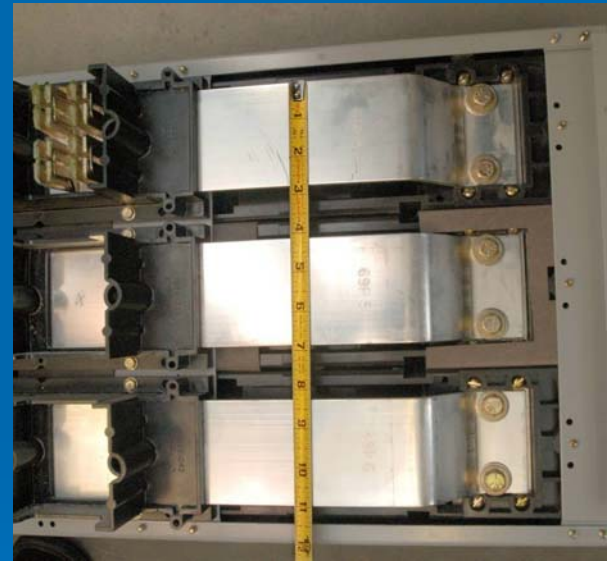
Undamaged switch

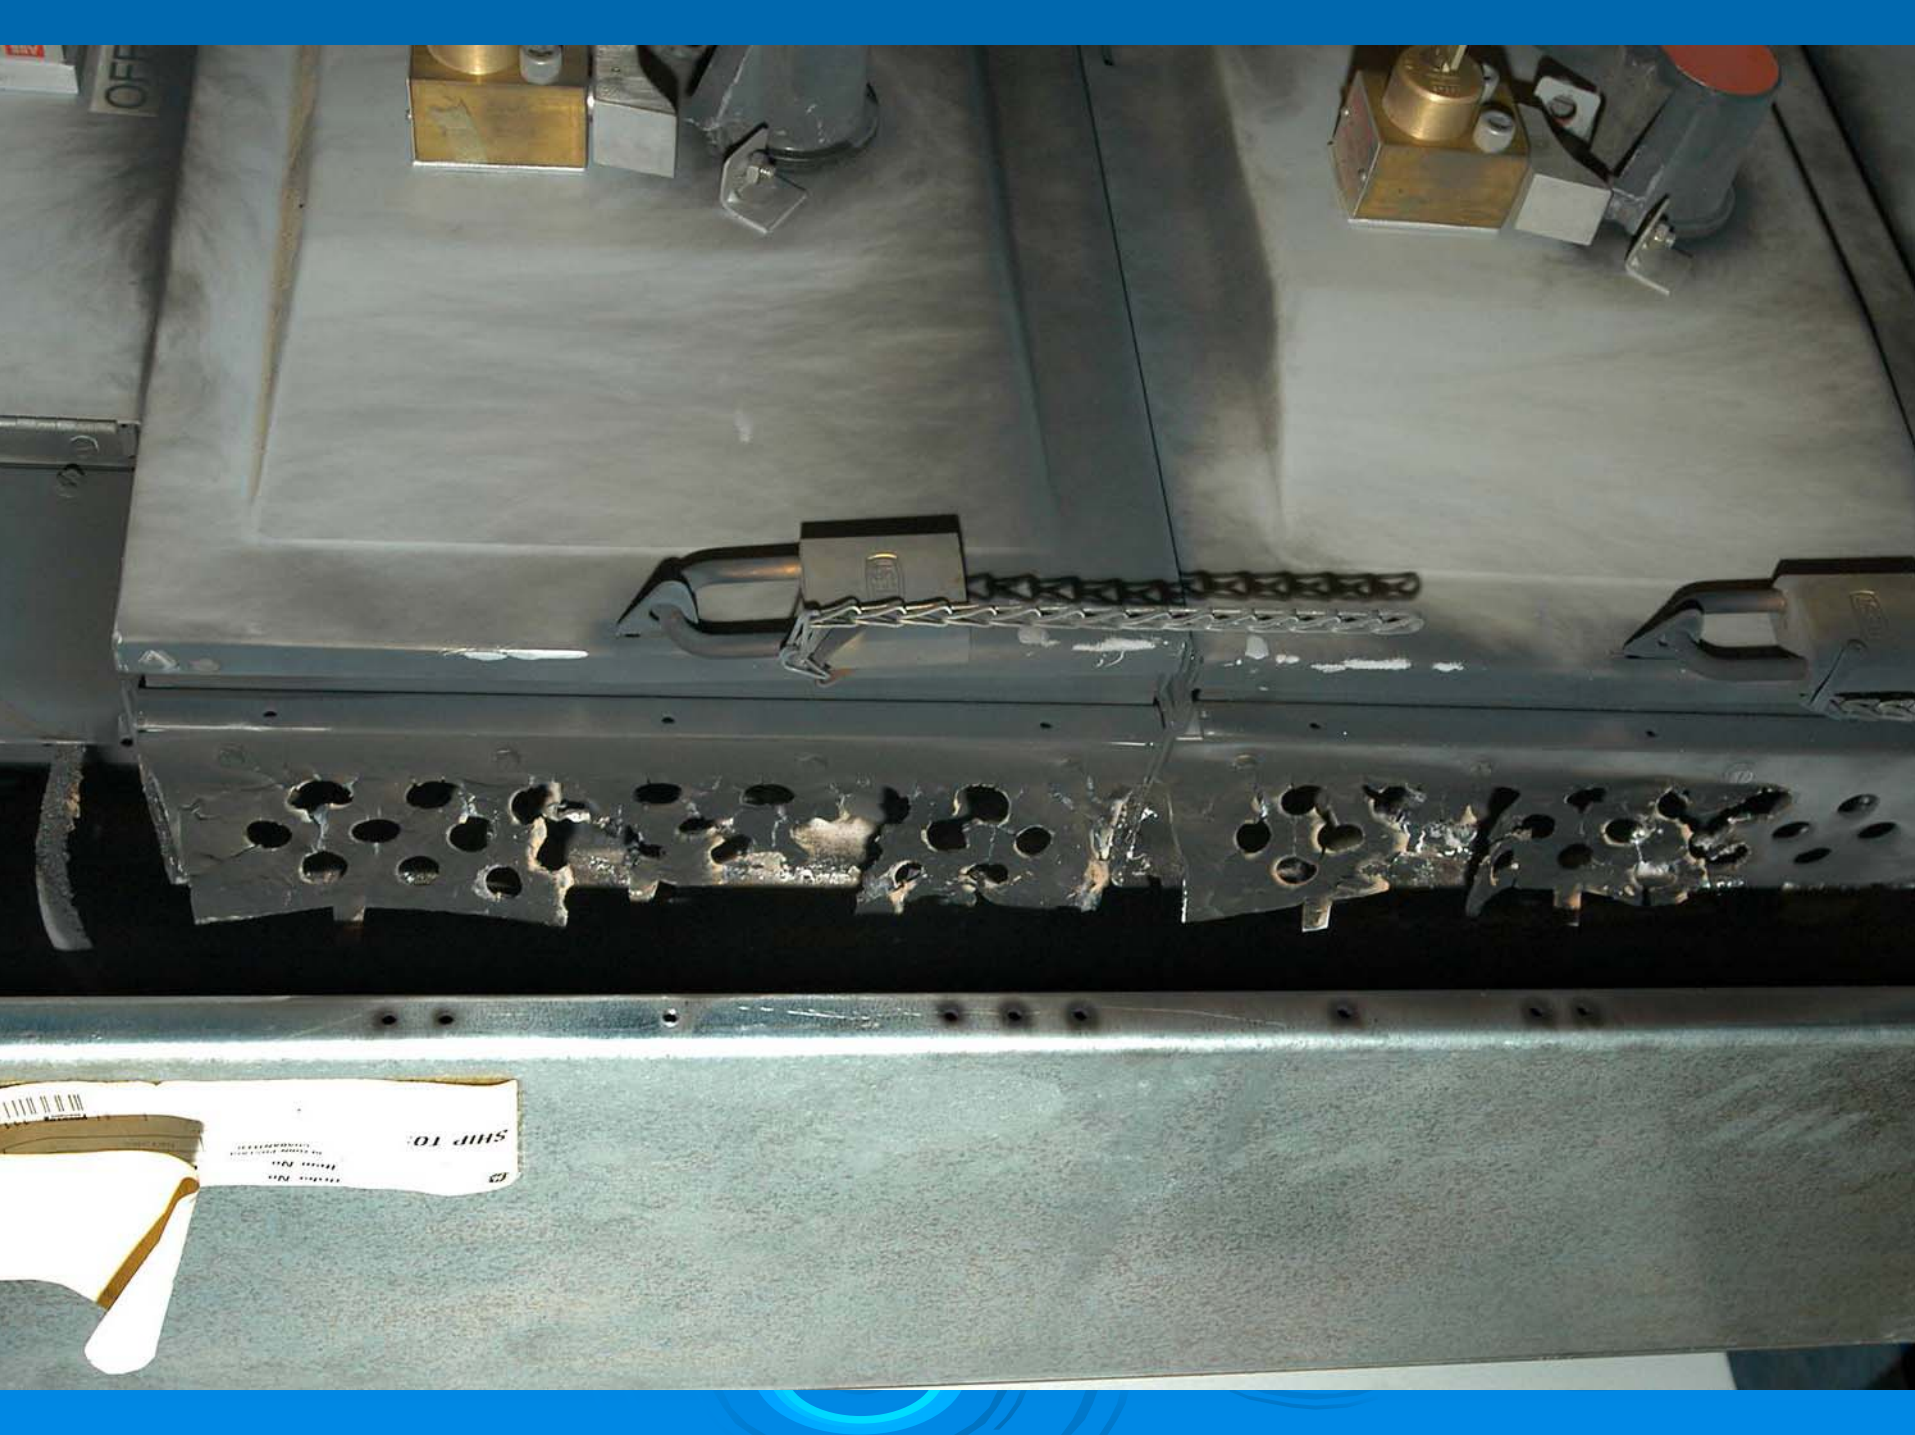
Rear view of switches
